University of Canterbury

Experimental Study on the Seismic Performance of Low Damage Systems for Non-structural Light Framed Plasterboard Partition Walls

ENEQ690 Master's Thesis

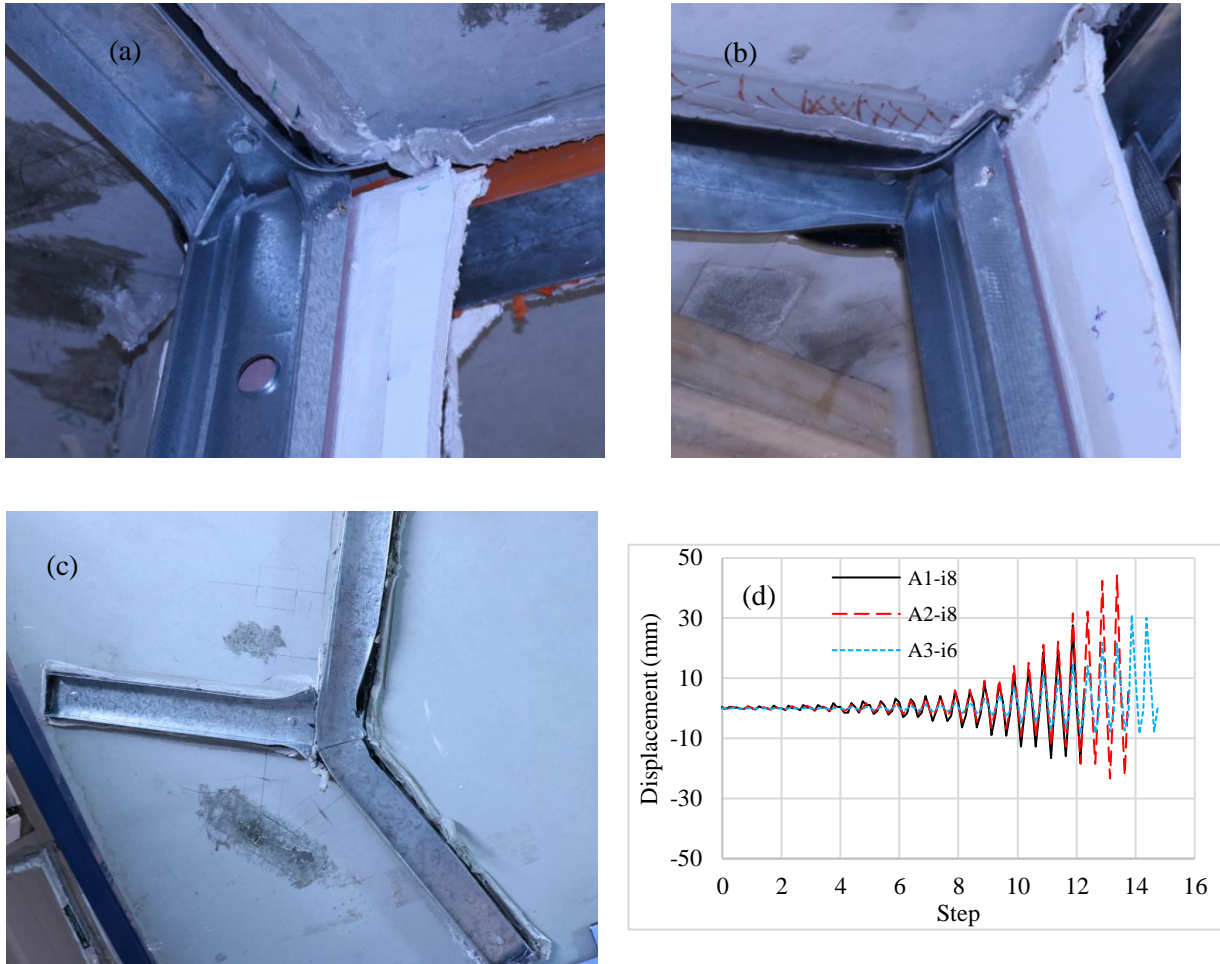
Figure 3.15 Damage to steel tracks at Y-junction for specimen (a) A1 (b) A2, and (c) A3. In particular showing bent flanges of 90° angled wall top track. (d) Shows the out-of-plane relative movement between 90° return wall at location 19 top corner and top slab for the three specimens (*data missing for specimen A1 due to instrumentation failure).

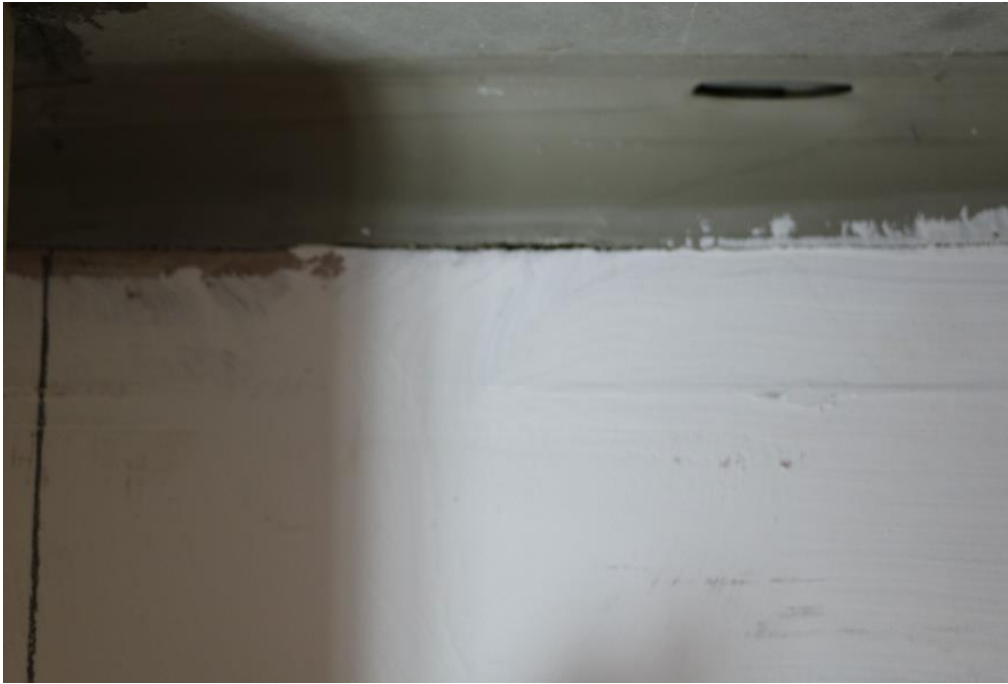
Figure B.4 Specimen A1 – Prior to test start - Defects in sealant bond - location 13

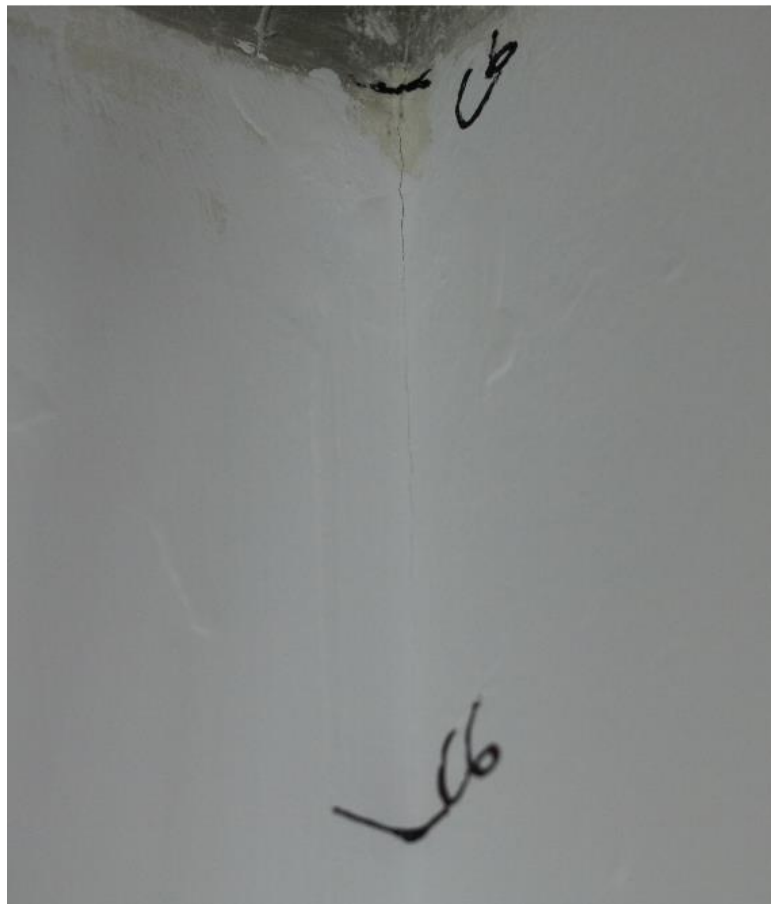
Figure B.5 Specimen A1 – Step 6 – DS0: Hairline paint cracking – location 11

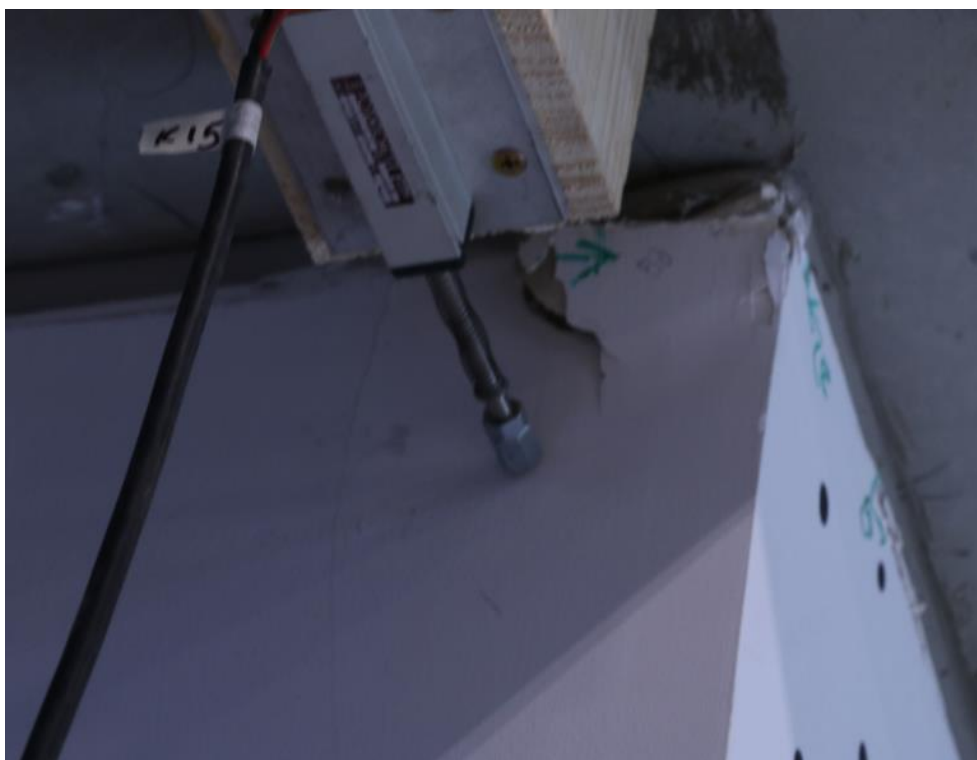
Figure B.10 Specimen A1 – Step 11 – DS2: cracking at wall end from pushing through of track – location 7

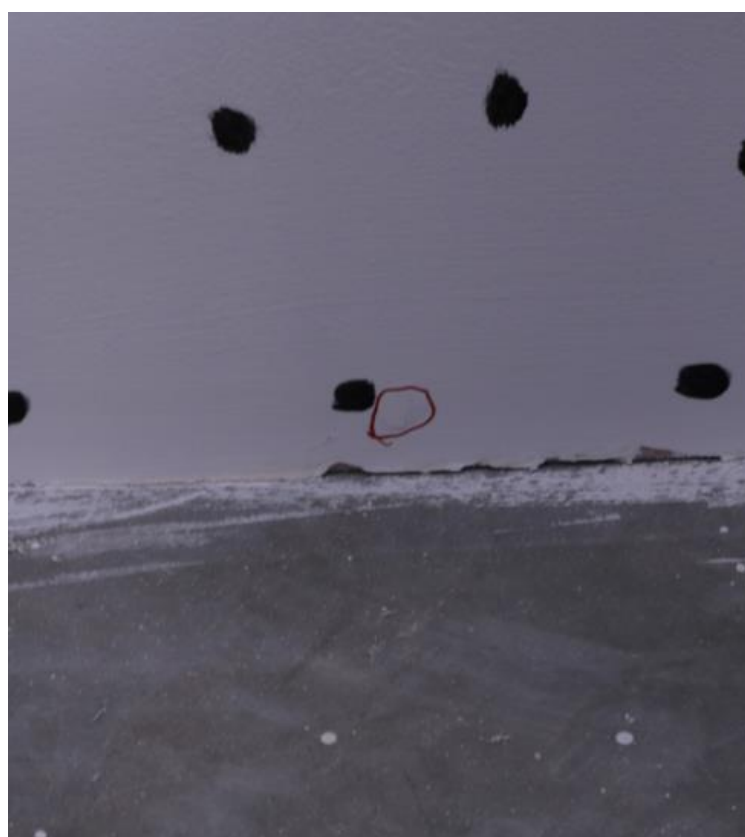
Figure B.11 Specimen A1 – Step 11 – DS1c: Popping of bottom track screw fixing head– location 3

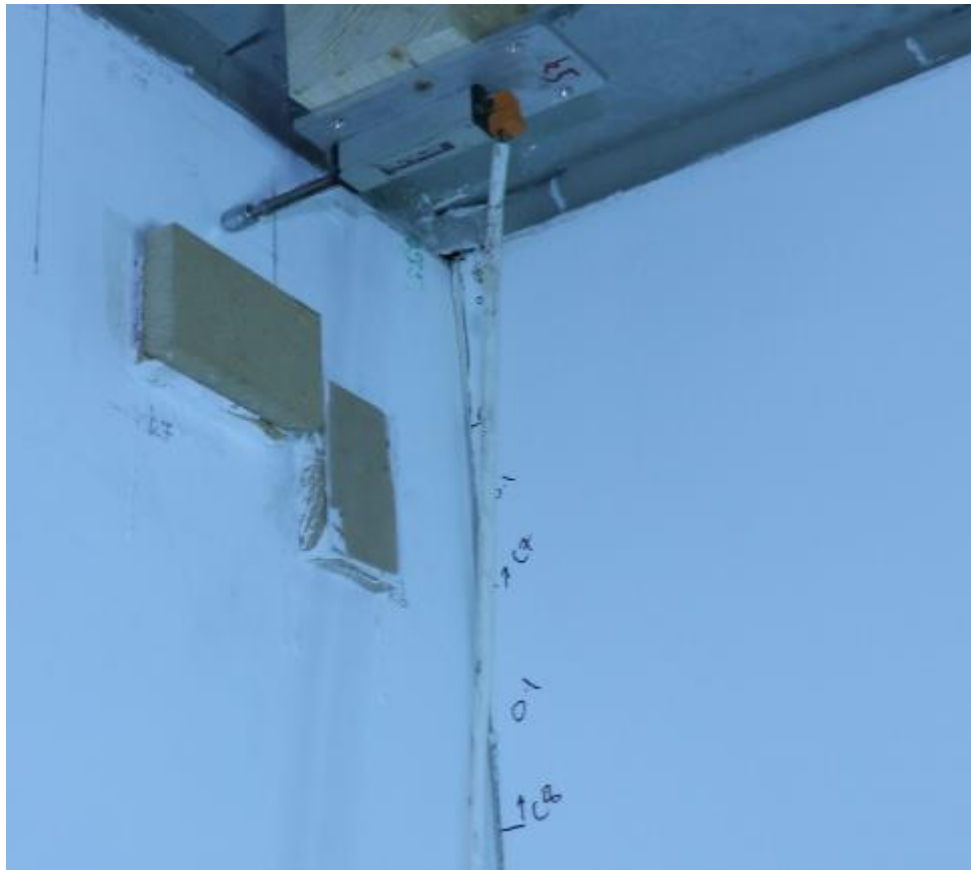
Figure B.15 Specimen A1 - Step 13 -- DS2: wallboard damage – location 11

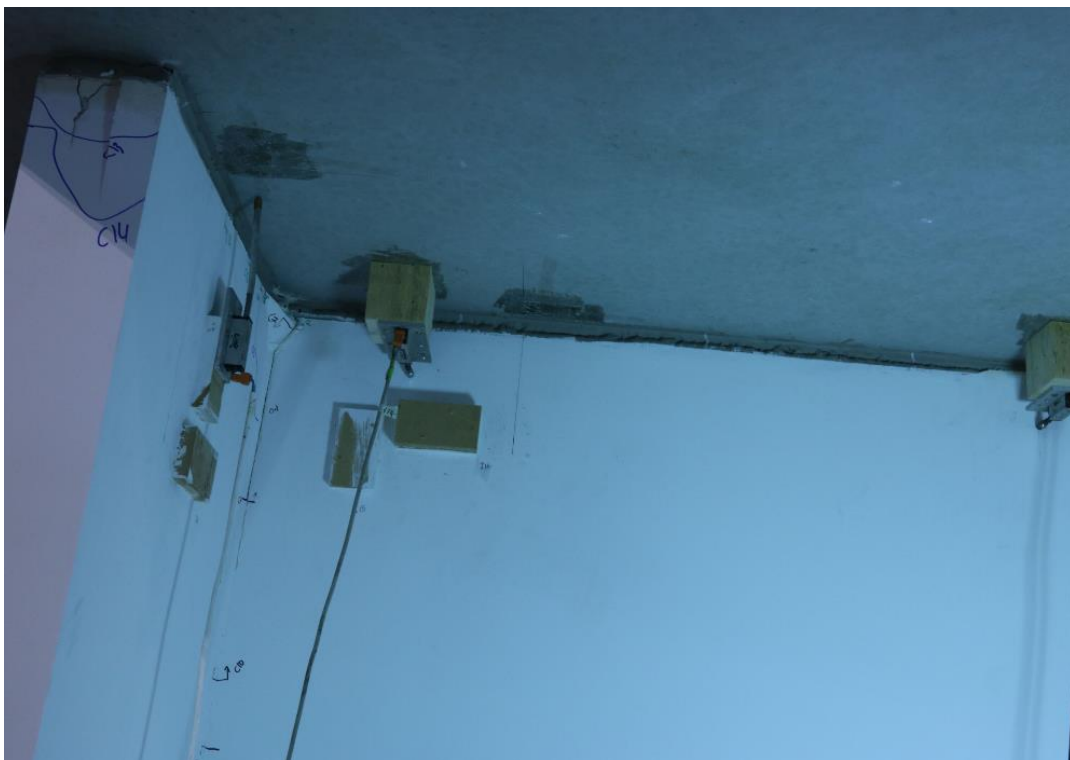
Figure B.17 Specimen A1 - Step 14 —A number of different forms of damage including rupturing of sealant along length of wall– locations 14-17

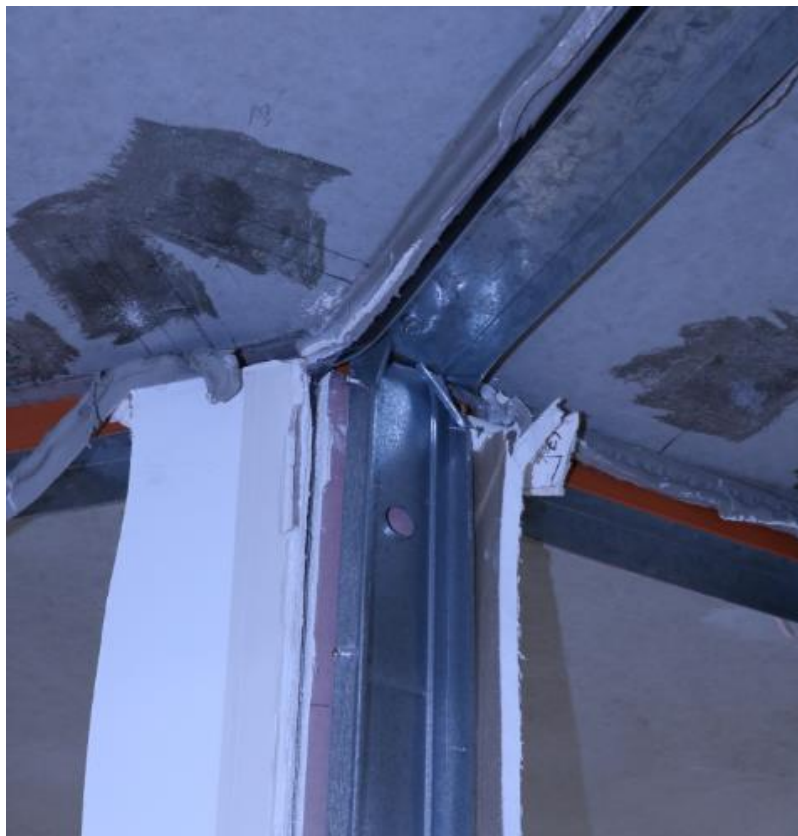
Figure B.21 Specimen A1 – Post-test framing inspection – bending of stud and track flanges at top including construction error – location 15 & 19

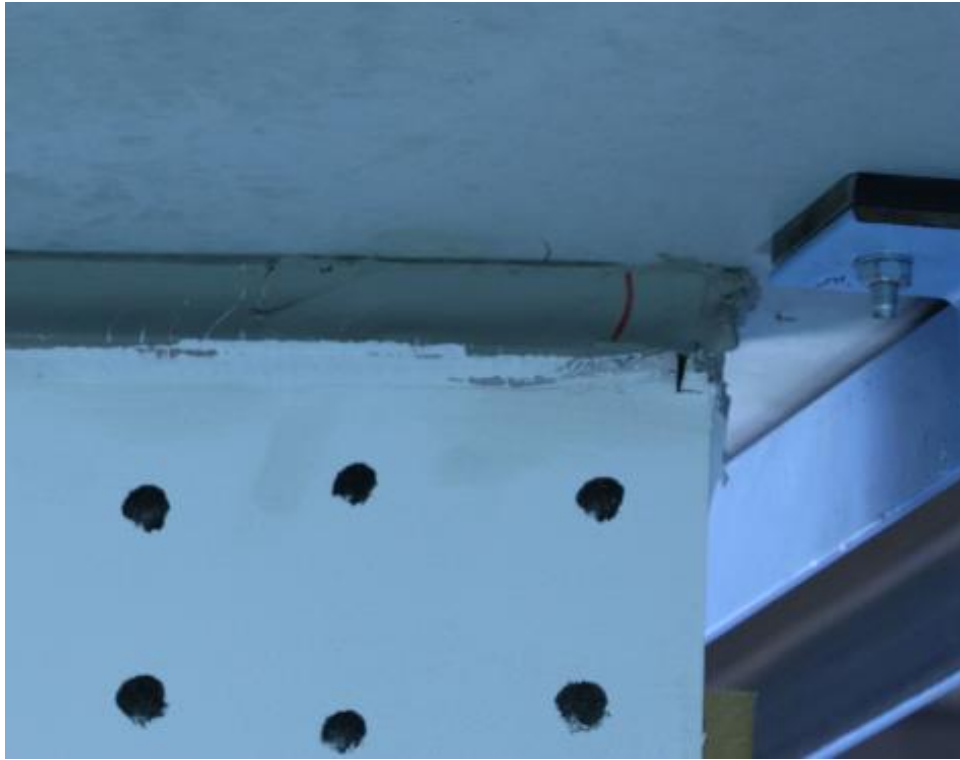
Figure B.26 Specimen A2 – Step 9 – DS1a: Sealant debonding – location 1

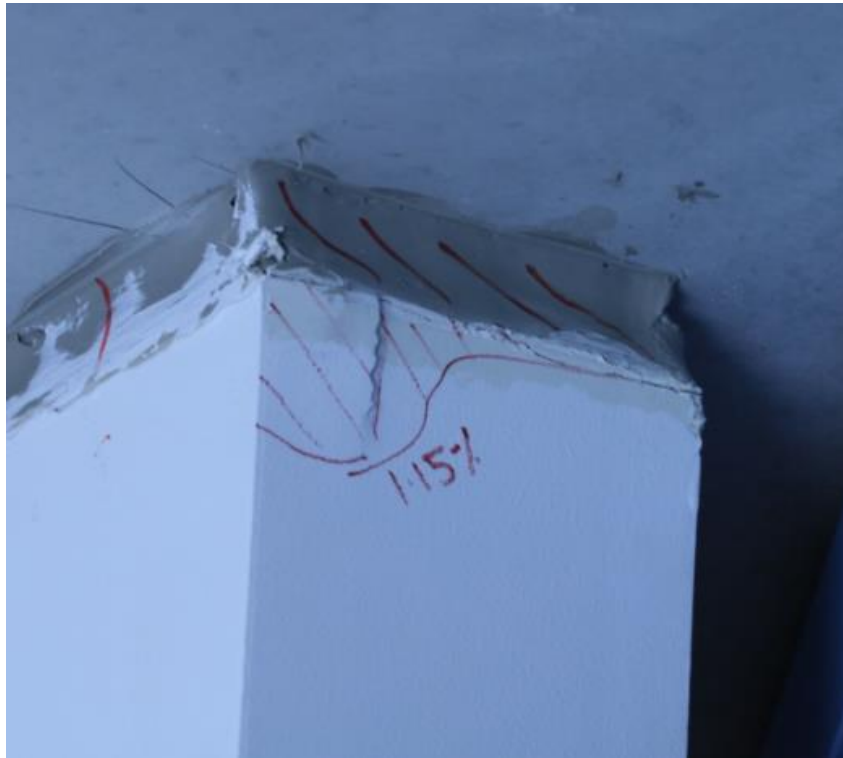
Figure B.30 Specimen A2 - Step 11 - DS2: Cracking of wallboard at wall end – location 9

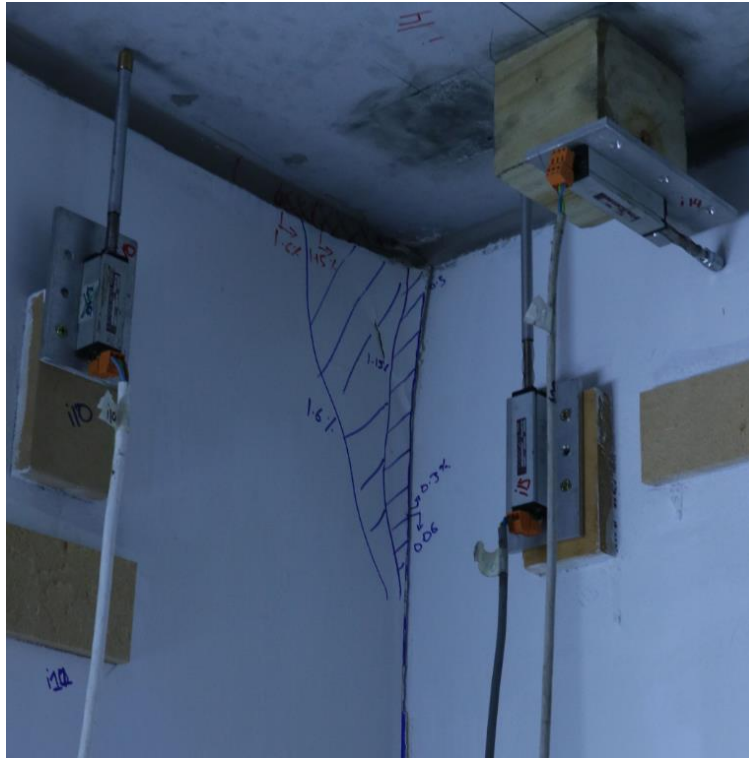
Figure B.32 Specimen A2 – Step 12 – DS2: Wallboard Damage– location 15 & 16

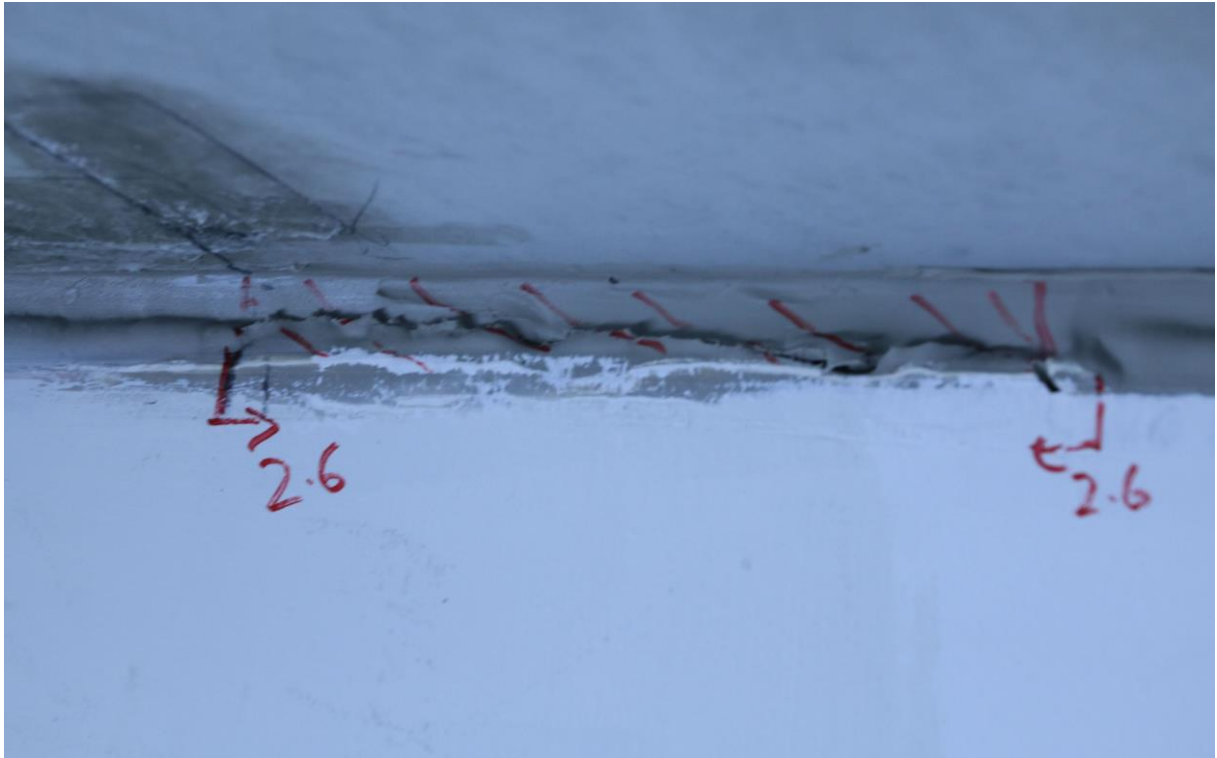
Figure B.34 Specimen A2 - Step 13 —DS1a: Sealant rupturing in shear (ass opposed to debonding)—location 13

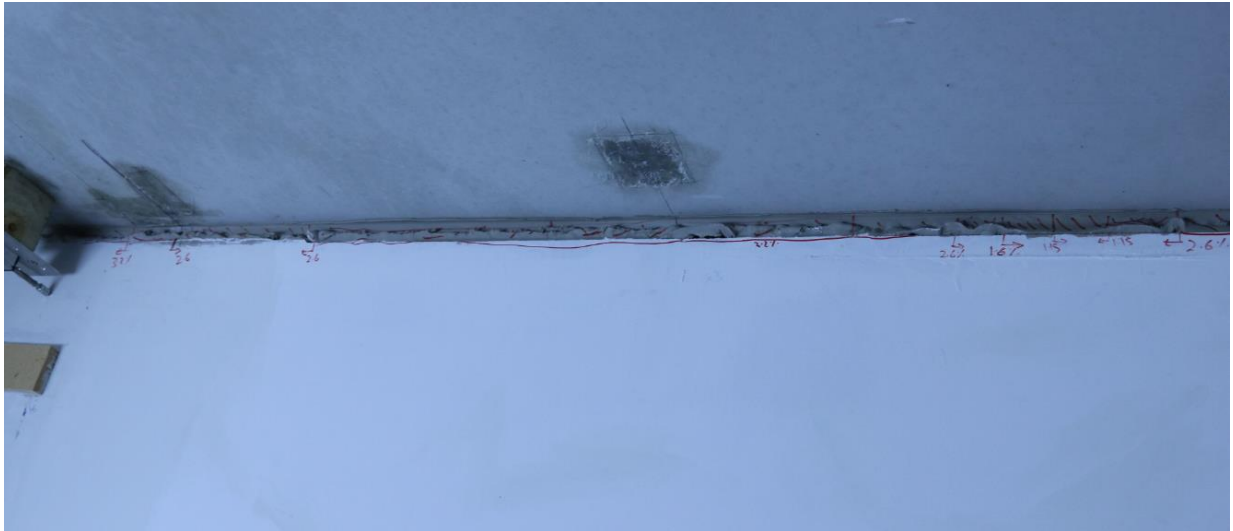
Figure B.36 Specimen A2 - Step 14 — DS1a: sealant rupturing— locations 12 to 14

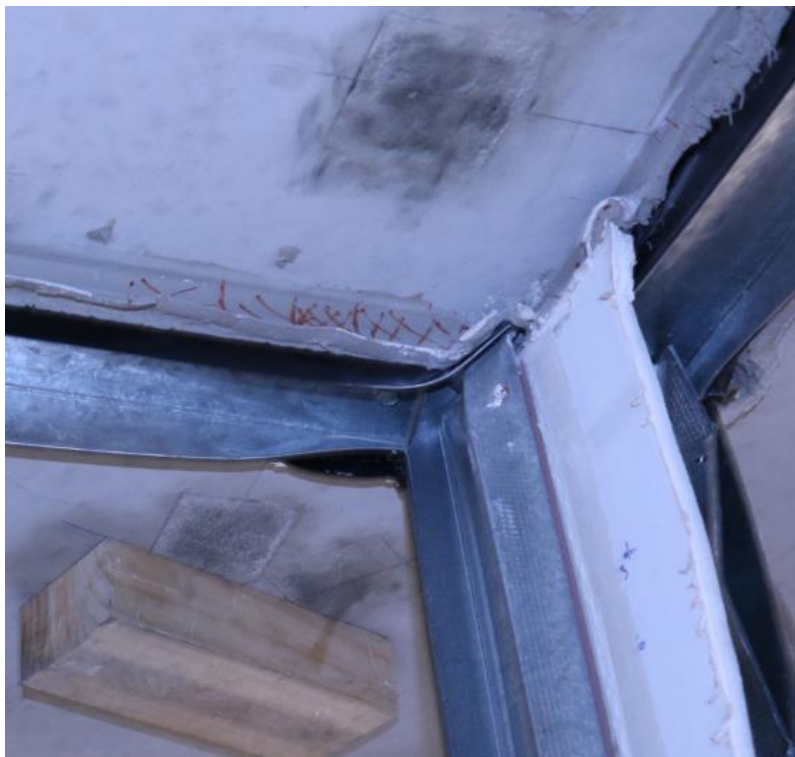
Figure B.43 Specimen A2 – Post-test framing inspection – bending of stud and track flanges at top including construction error – location 15 & 19

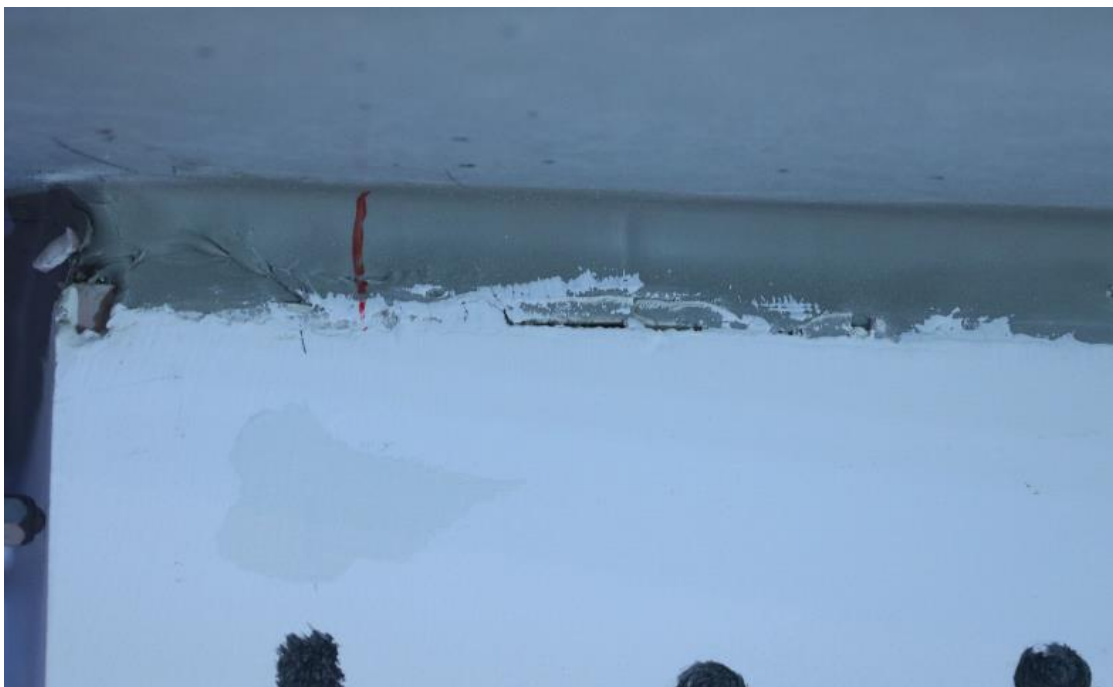
Figure B.45 Specimen A3 – Prior to test start – Defects in sealant bonding at corner junction – location

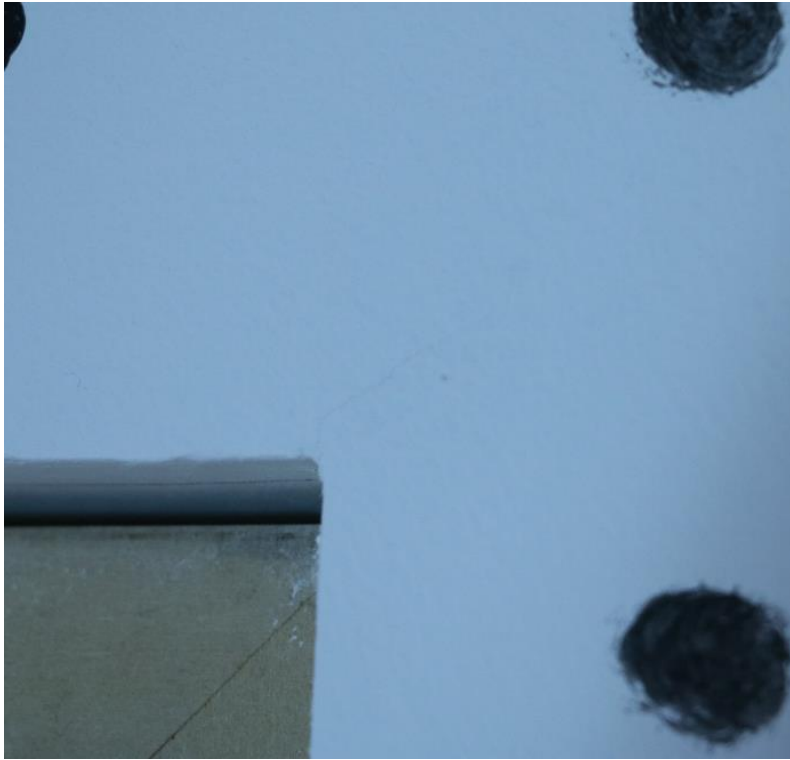
Figure B.46 Specimen A3 – Prior to test start– DS0: hairline paint cracking at the corner of door frame - location 13

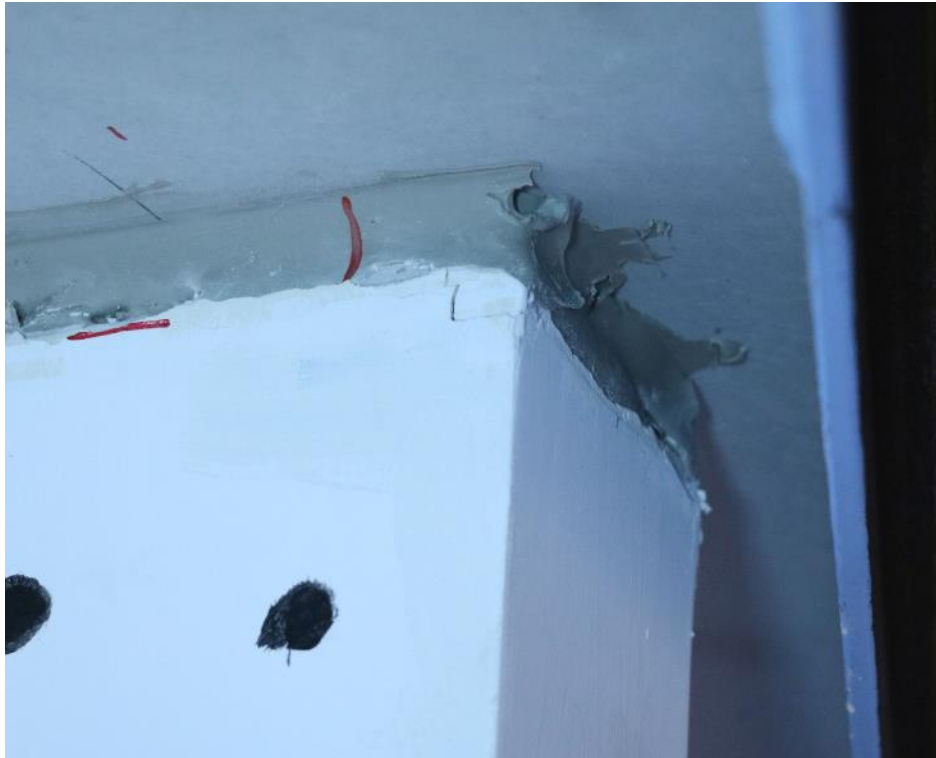
Figure B.52 Specimen A2 – Step 9 – DS1b: Plaster damage– location 21

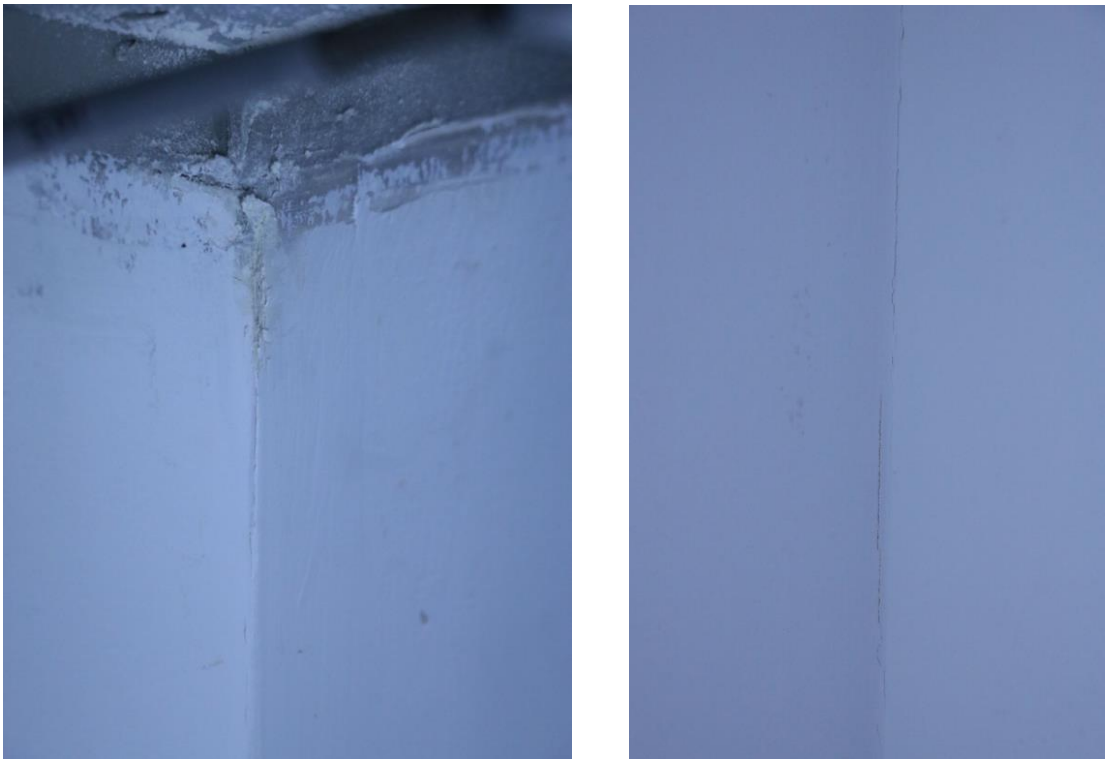
Figure B.53 Specimen A3 - Step 10 – DS1b: Plaster cracking – location 11

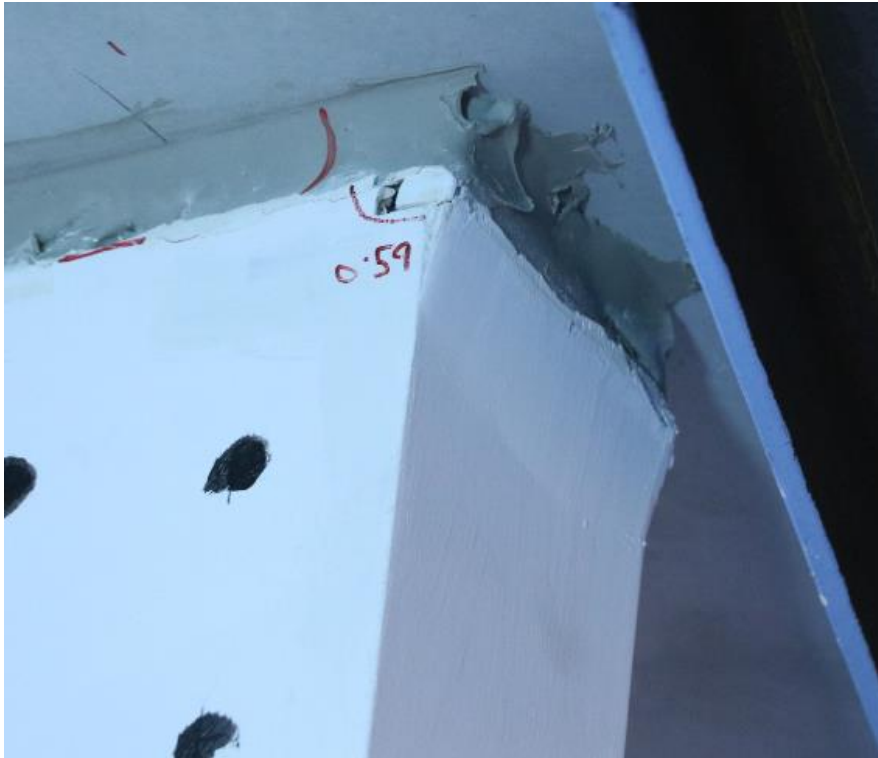
Figure B.54 Specimen A3 – Step 21 – DS2: Wallboard Damage– location 21

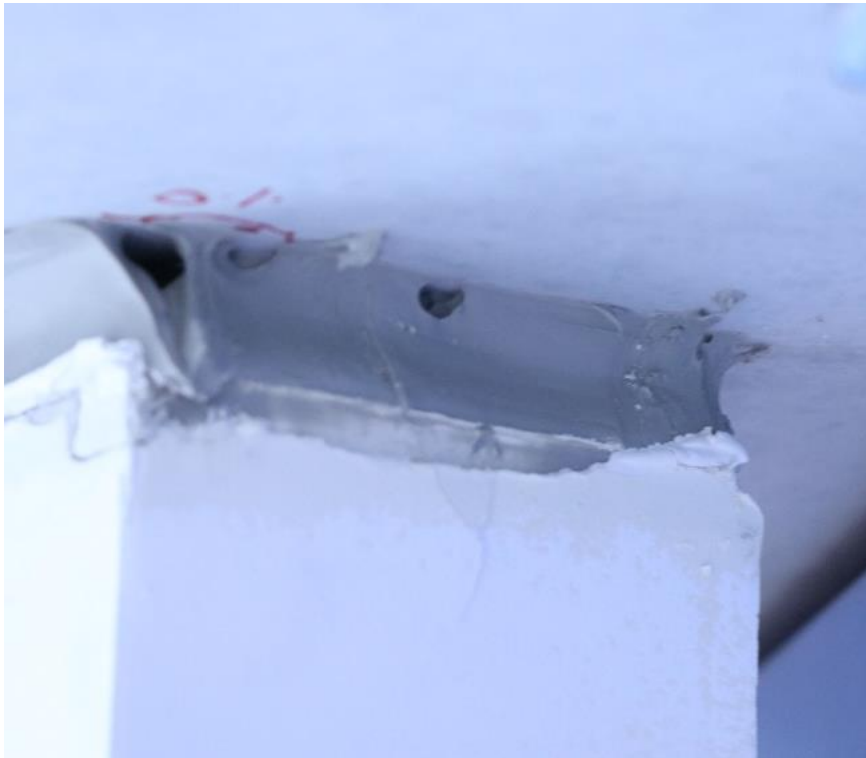
Figure B.55 Specimen A3 – Step 11 – DS2: wallboard damage due to top track pushing through–
location 9

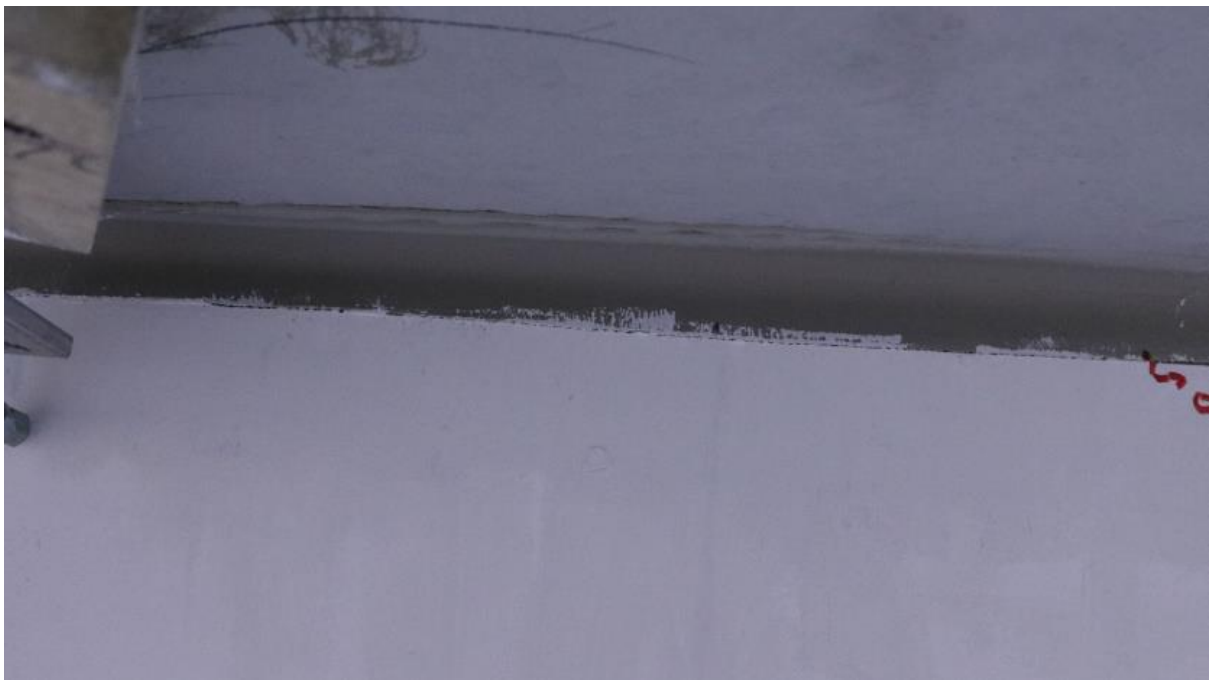
Figure B.57 Specimen A3 - Step 11 – DS1a: Separation of sealant from plasterboard lining – location 18

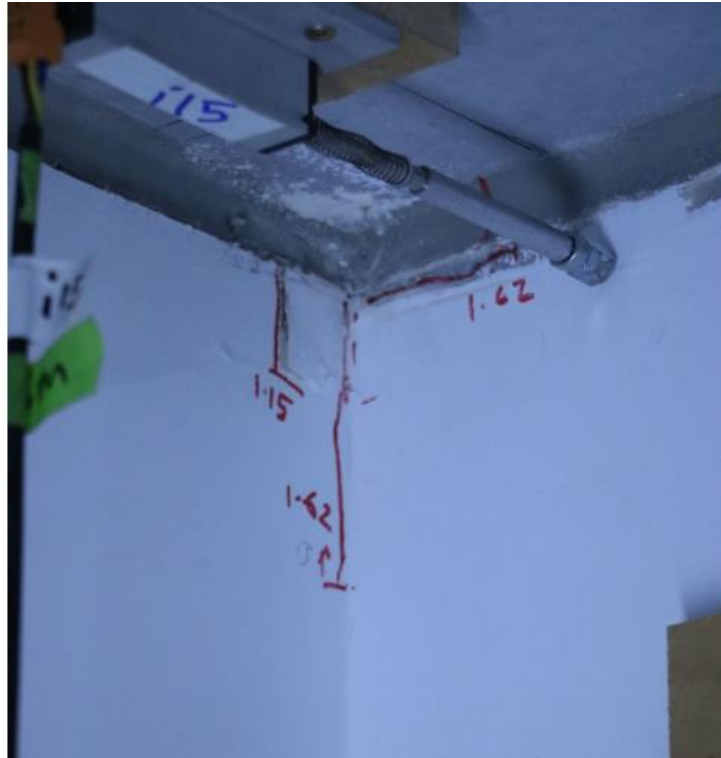
Figure B.58 Specimen A3 - Step 12 -- DS2: Wallboard damage – location 15

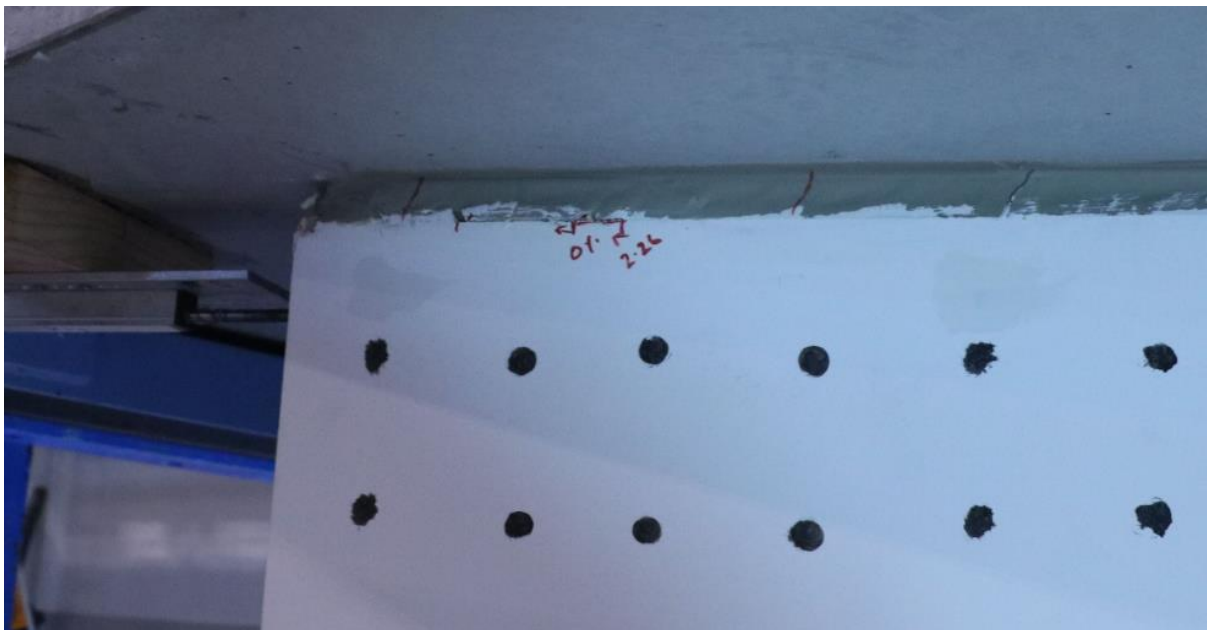
Figure B.59 Specimen A3 - Step 13 -- DS1a: Sealant debonding – location 6

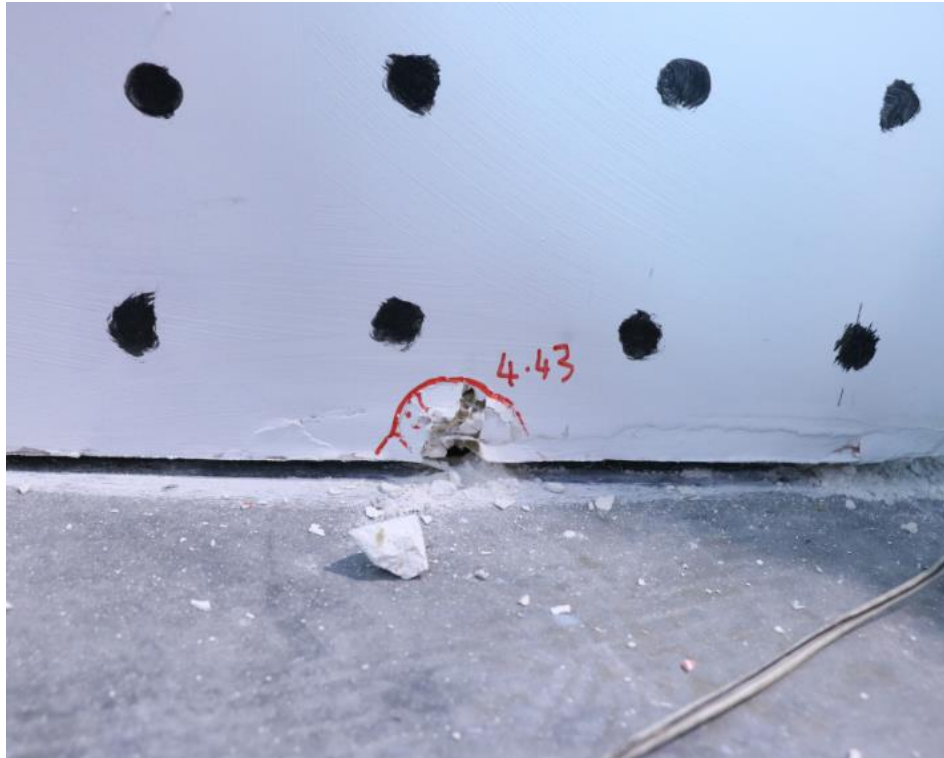
Figure B.62 Specimen A3 - Step 15– DS1c & 2: screw damage and wallboard damage around screw head– location 1

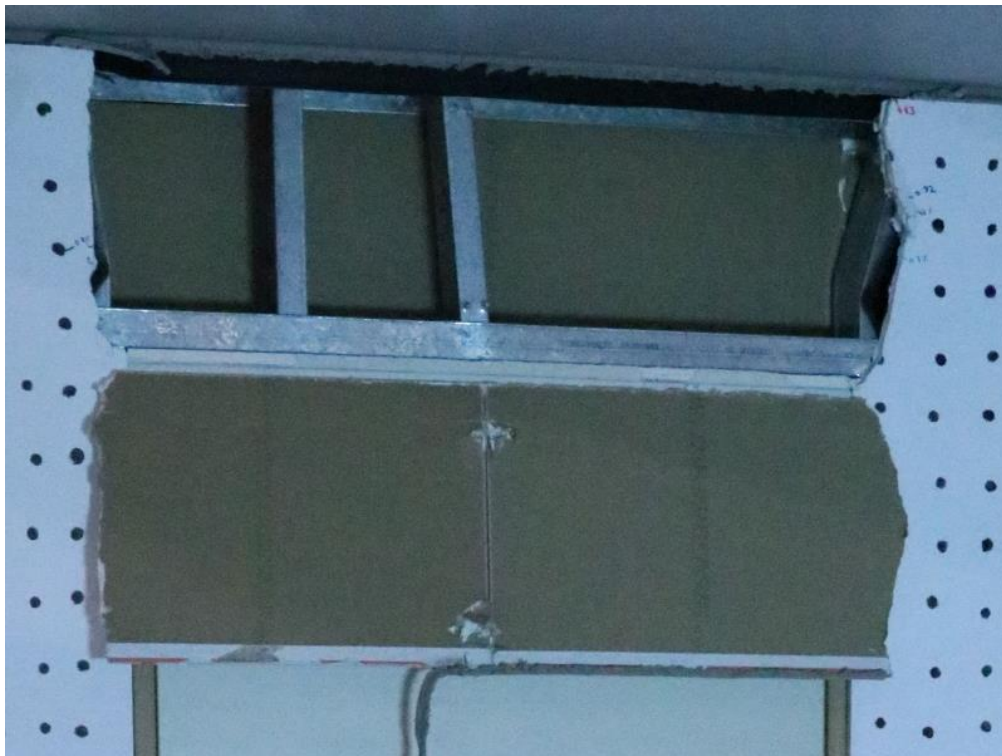
Figure B.63 Specimen A3 - Step 16– DS3: spalling of wallboard revealing buckling of studs above door frame– location 4

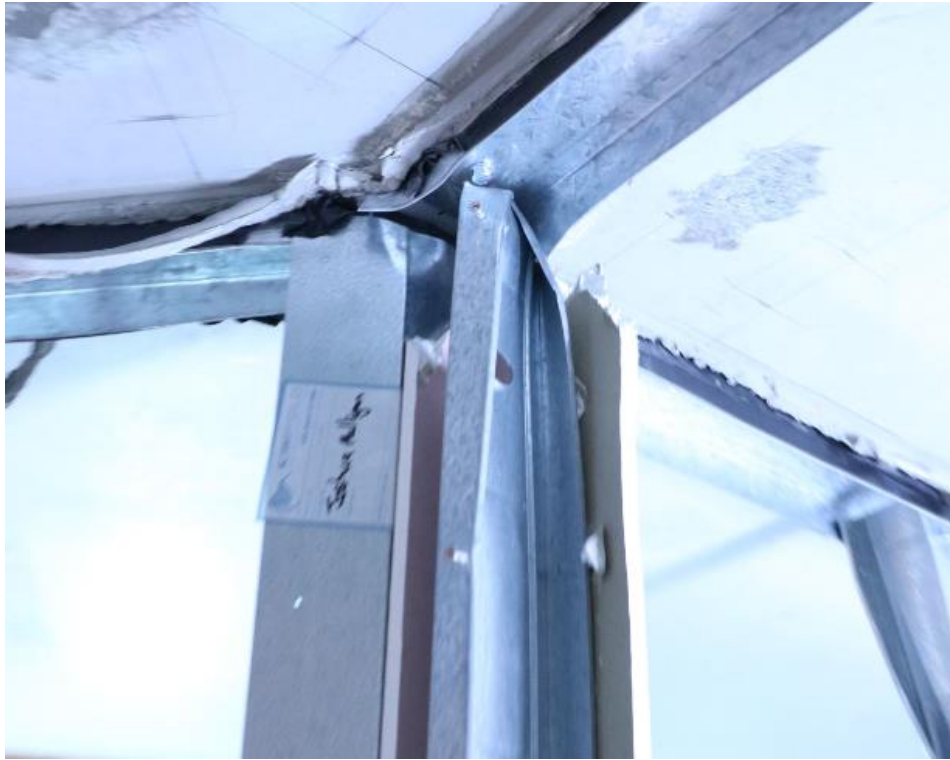
Figure B.68 Specimen A2 – Post-test framing inspection – bending of stud and track flanges at top including construction error – location 15 & 19

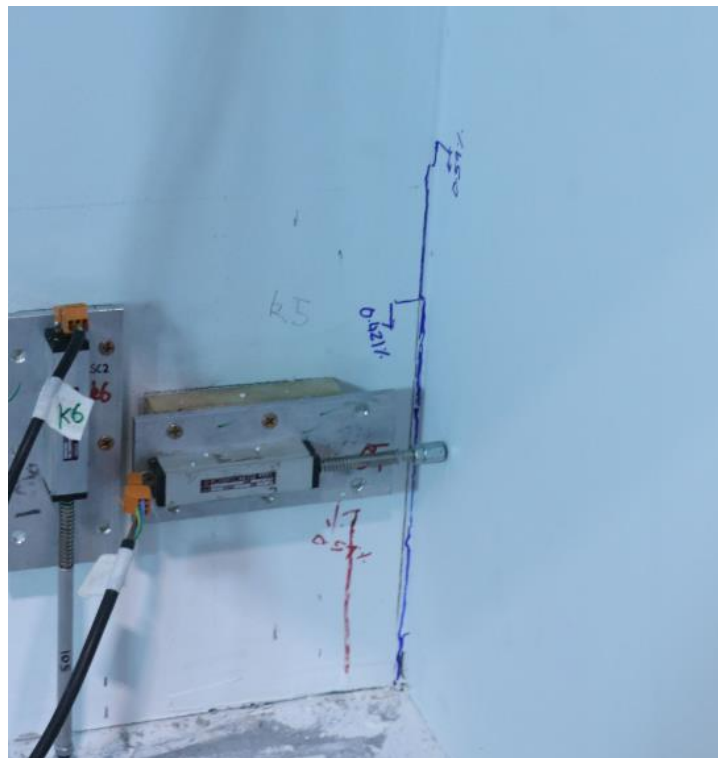
Figure C.9 Specimen B1 – Step 9 – DS1a & b: Debonding of gap filler and plaster cracking along L-trim at L-junction bottom corner- location 11

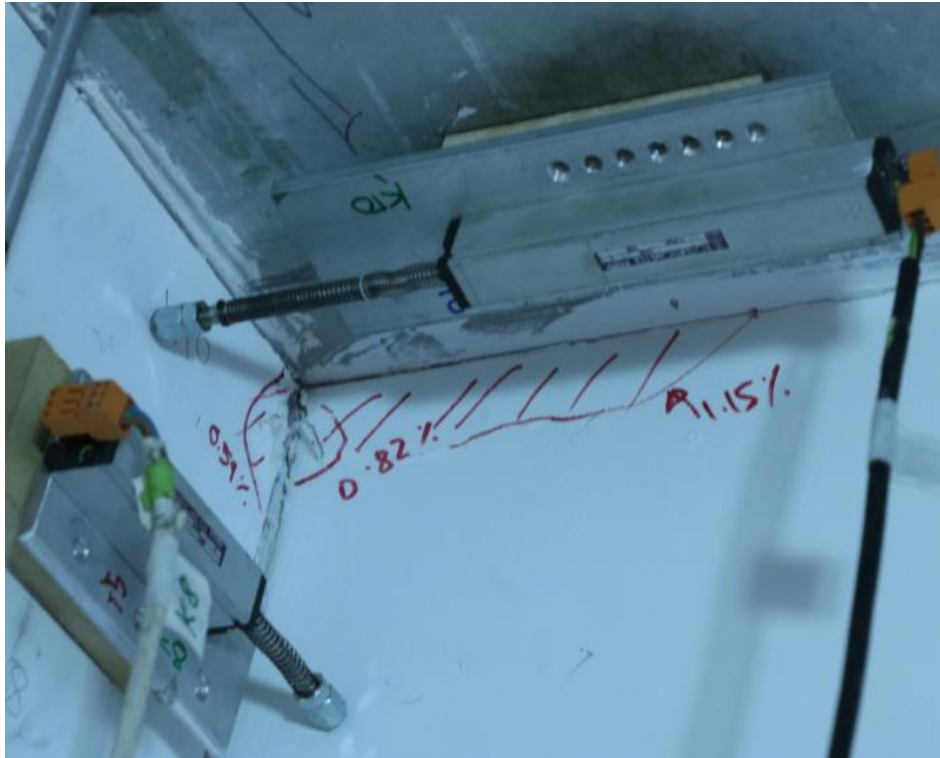
Figure C.14 Specimen B1 – Step 11 – DS1b & 2a: Cracking of plaster along L-trim and damage to wallboard– location 10

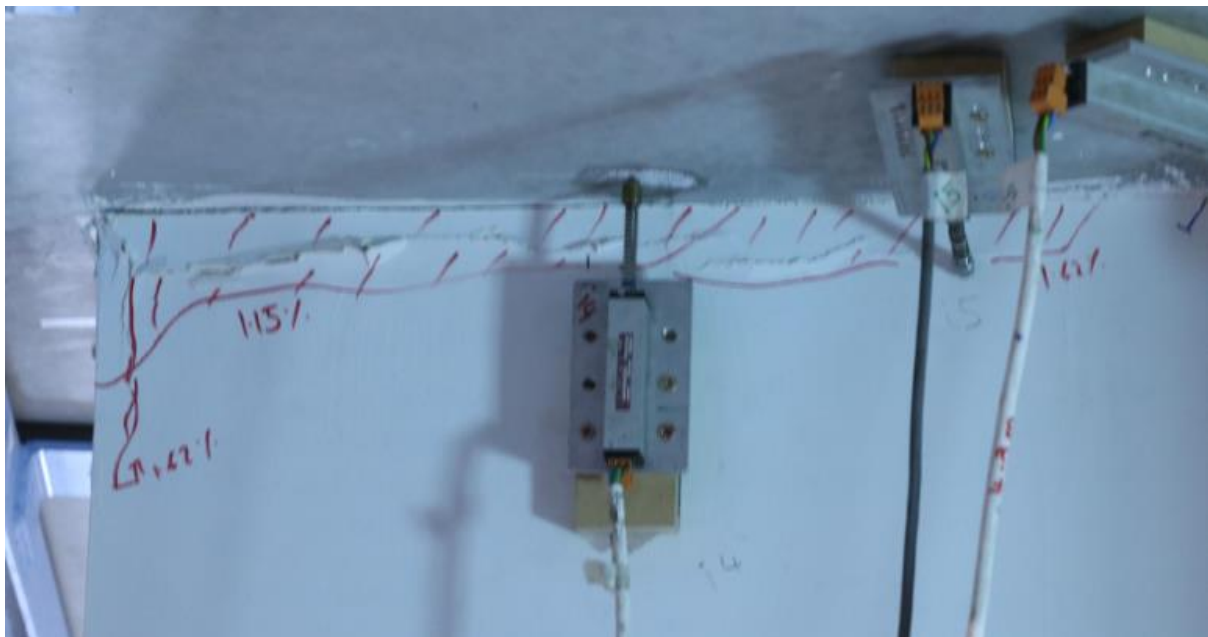
Figure C.17 Specimen B1 – Step 12 – DS1b: Plaster cracking along L-Trim – location 20

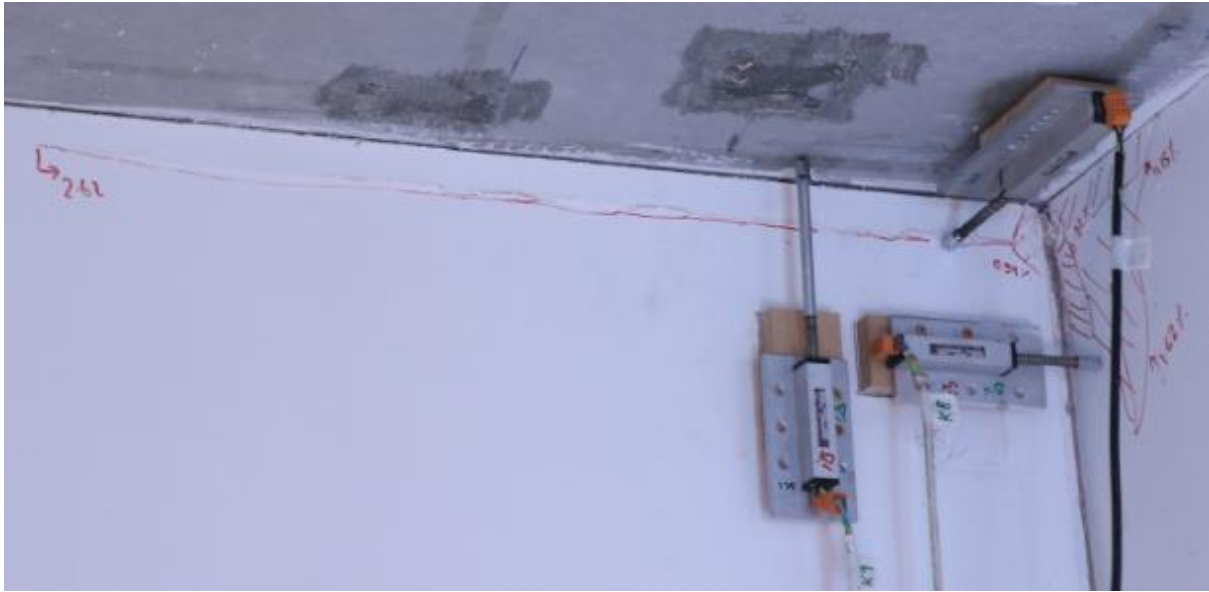
Figure C.18 Specimen B1 – Step 13 – DS1b: Plaster cracking along L-Trim – location 13
